# **YAXLEY PARISH COUNCIL**

Asbestos Survey Report  
for  
The Workshop  
48 Main Street  
Yaxley  
Peterborough, PE7 3LU

Asbestos Survey Report  
for  
The Pavilion  
48 Main Street  
Yaxley  
Peterborough, PE7 3LU

Asbestos Survey Report  
for  
Amenity Centre  
Yaxley Parish Council  
48 Main Street  
Yaxley  
Peterborough, PE7 3LU

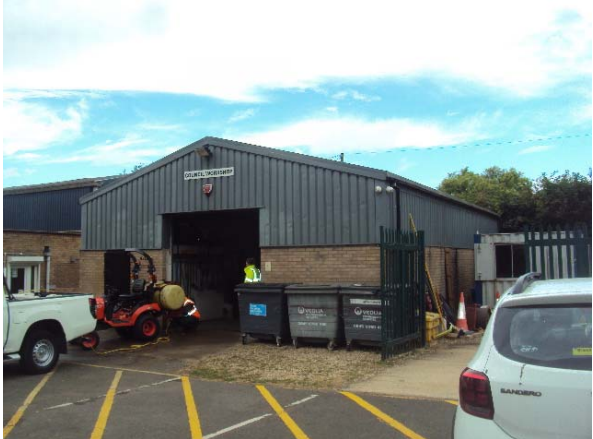
1

<p>External view. Metal cladding to roof and walls, brick to walls at lower level. No asbestos containing materials seen here.</p>
2

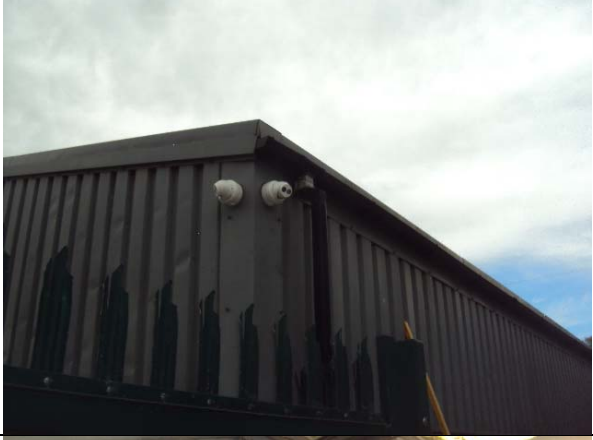
<p>Metal cladding to roof and walls. Plastic rainwater goods. No asbestos containing materials seen here.</p>
3

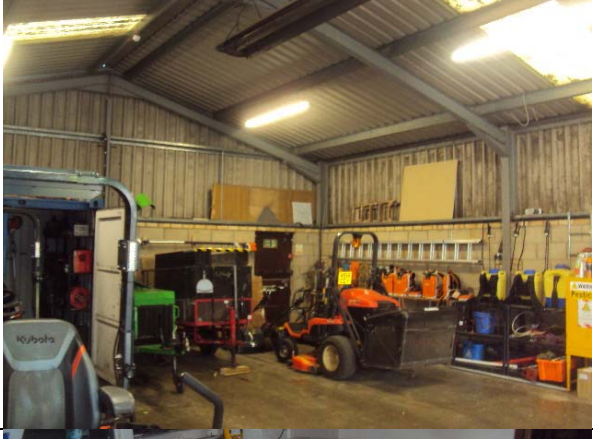
<p>Steel frame clad with metal cladding, brick and block walls, concrete floor. No asbestos containing materials seen here.</p>
4

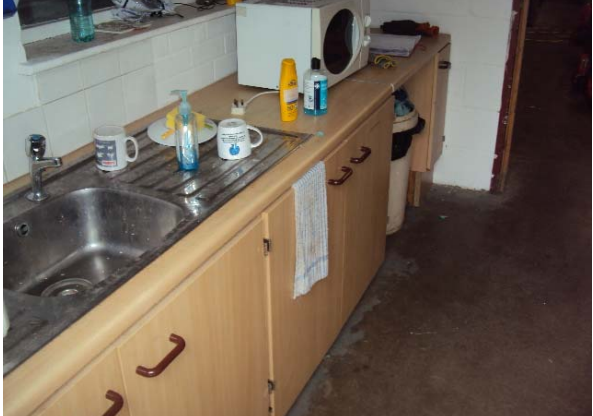
<p>Modern type kitchen fixtures and fittings. No asbestos containing materials seen here.</p>

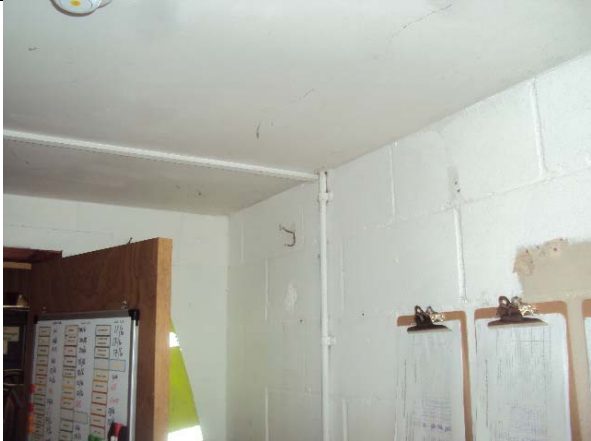
5

<p>Timber/plasterboard finishes to office/staff area. No asbestos containing materials seen here.</p>
6

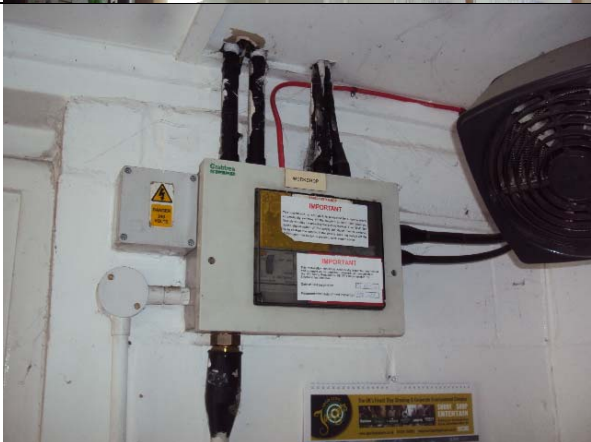
<p>No asbestos containing materials seen here, in or around the electrical installation.</p>
7

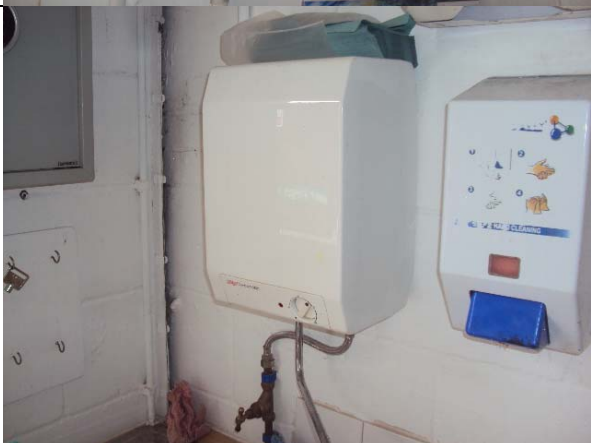
<p>These water heaters do not contain asbestos products.</p>

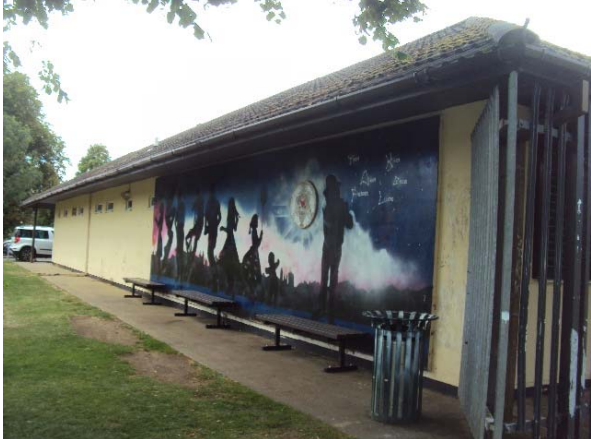
1

<p>External view. Concrete roof tiles, plastic rainwater goods, timber fascia and soffit boards. No asbestos containing materials seen here.</p>
2

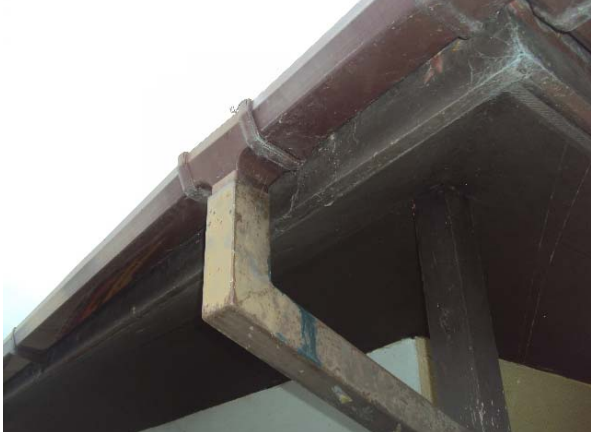
<p>Plastic rainwater goods, timber fascia and soffit boards. No asbestos containing materials seen here.</p>
3

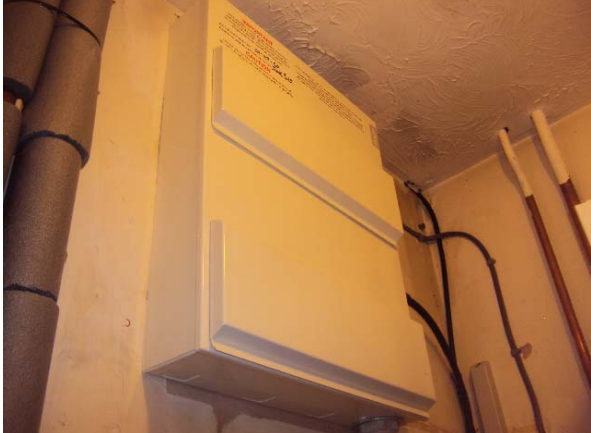
<p>No asbestos containing materials seen here, in or around the electrical installation.</p>
4

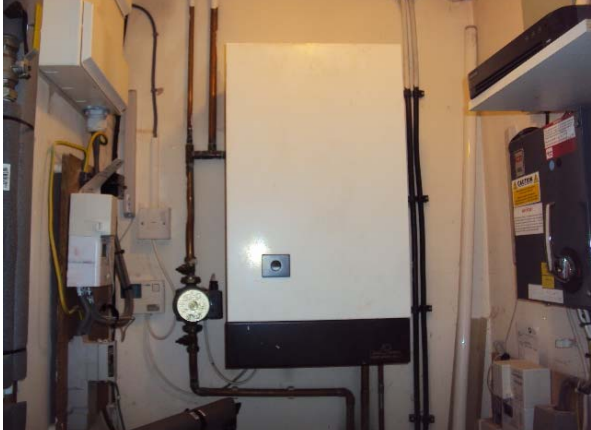
<p>Modern boiler with steel flue. No asbestos containing materials seen here.</p>

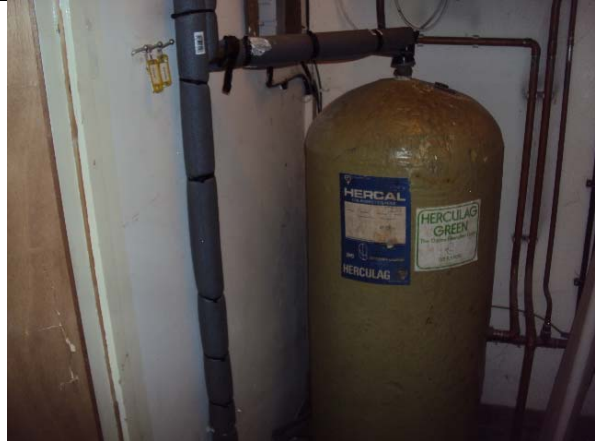
5

No asbestos containing materials found to the insulation to water vessels and pipes.
6

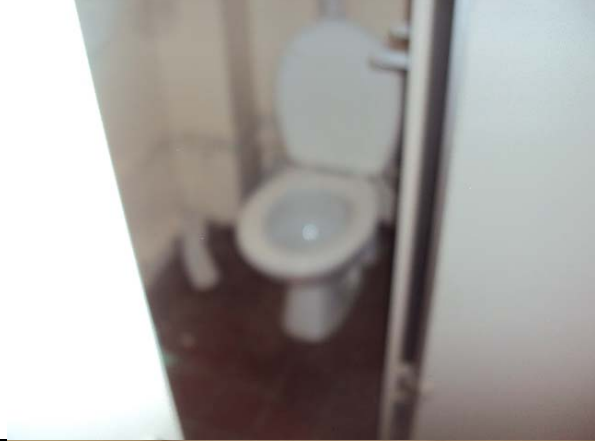
China sanitary units, ceramic floor tiles. No asbestos containing materials seen here.
7

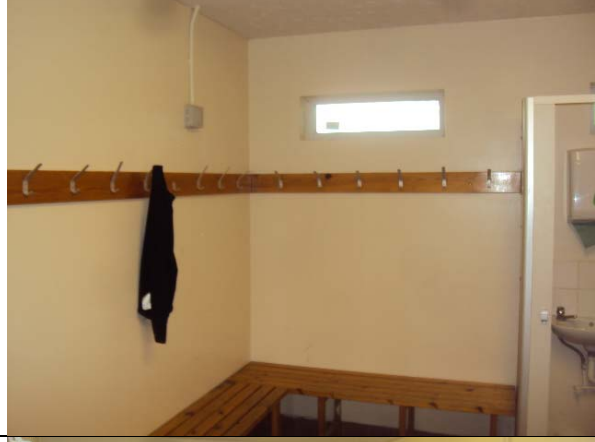
Plaster/plasterboard to walls and ceilings, textured coatings checked. No asbestos containing materials seen here.
8

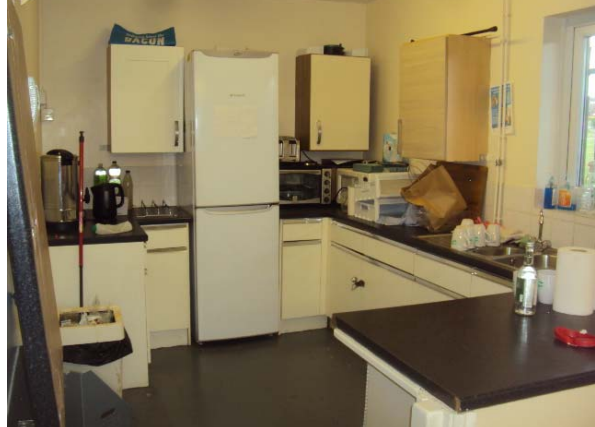
Modern type kitchen fixtures and fittings. No asbestos containing materials seen here.

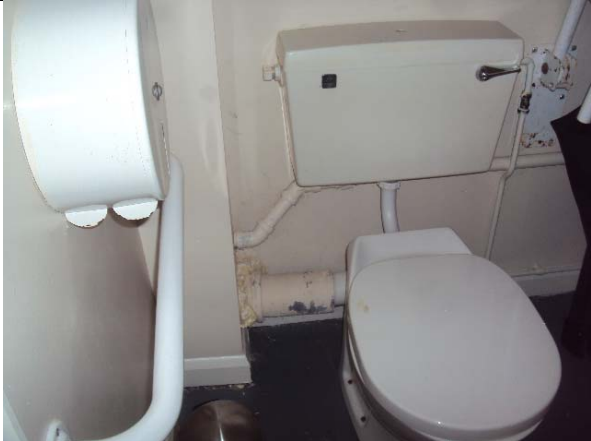
9

<p>Plastic drainpipes to saniray units. No asbestos containing materials seen here.</p>
10

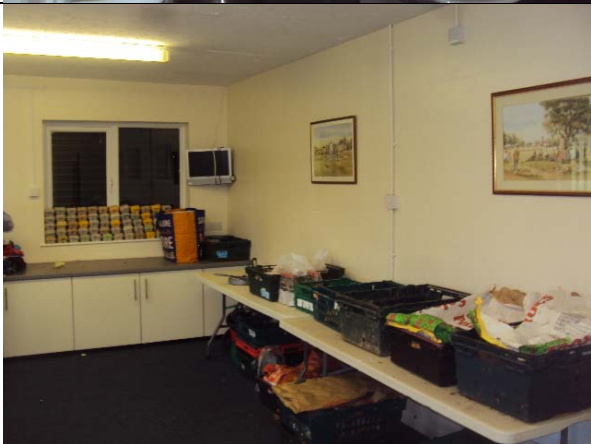
<p>All areas checked. No asbestos containing materials seen here.</p>

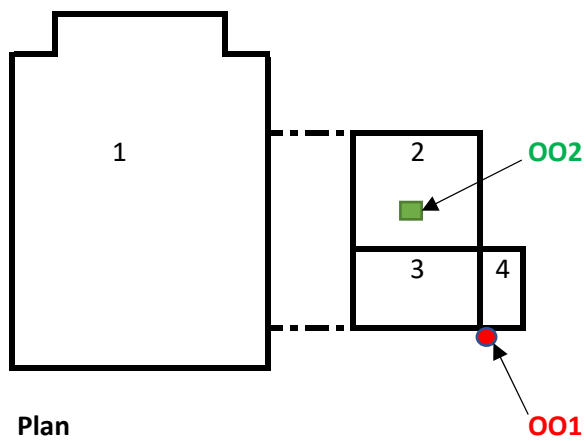
## Chapel at Yaxley Cemetery

Areas highlighted in red indicate an Asbestos Containing Material Present

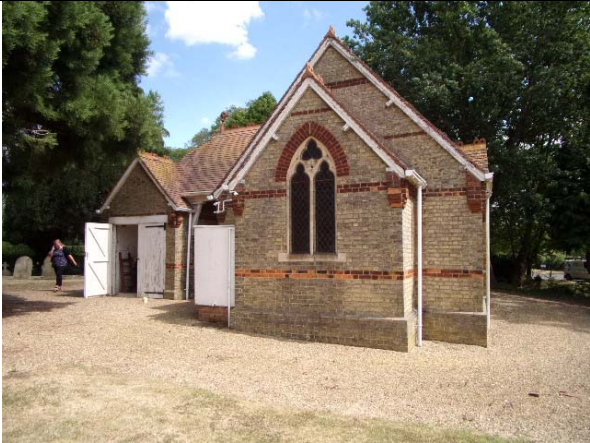
1

External view. Clay roof tiles, timber fascia/soffit boards, brick/stone walls, timber doors and frames. Sample 001 refers to the vent pipe.
2

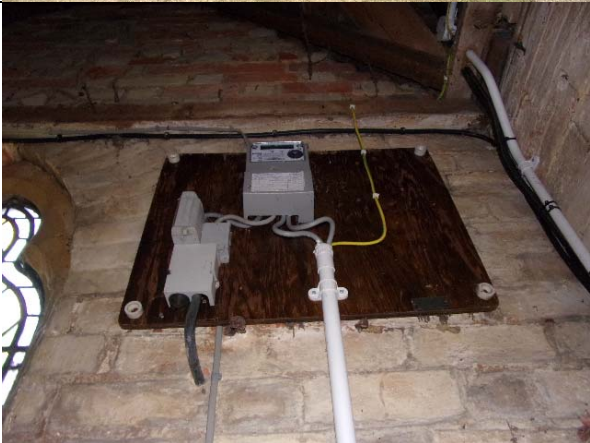
The electrics were checked. No asbestos containing materials seen here.
3

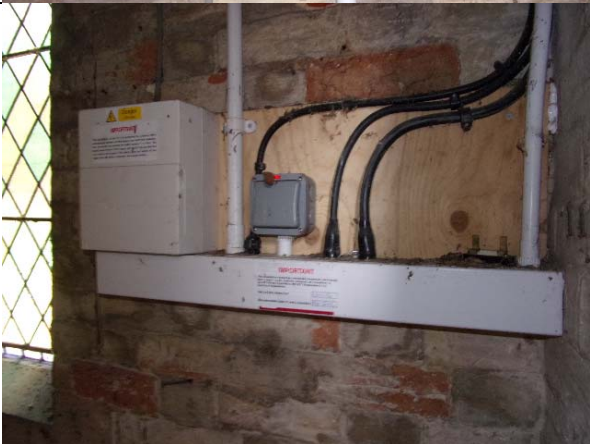
No asbestos containing materials seen here, in or around the electrical installations.
4

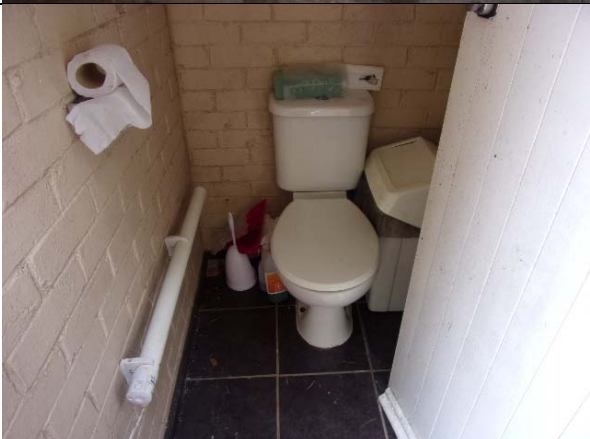
China sanitary units, ceramic floor tiles. No asbestos containing materials seen here.

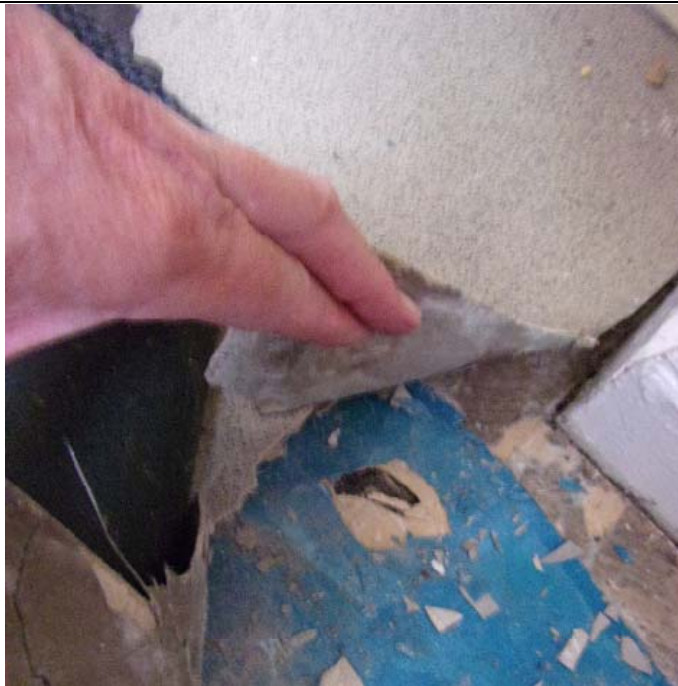
<b>baac</b> building & asbestos applications cambridgeshire	<b>This sample does not contain Asbestos</b>	
	Sample No	ACY/08/002
	Room / Area	08 - Kitchen
	Component	Textured coating

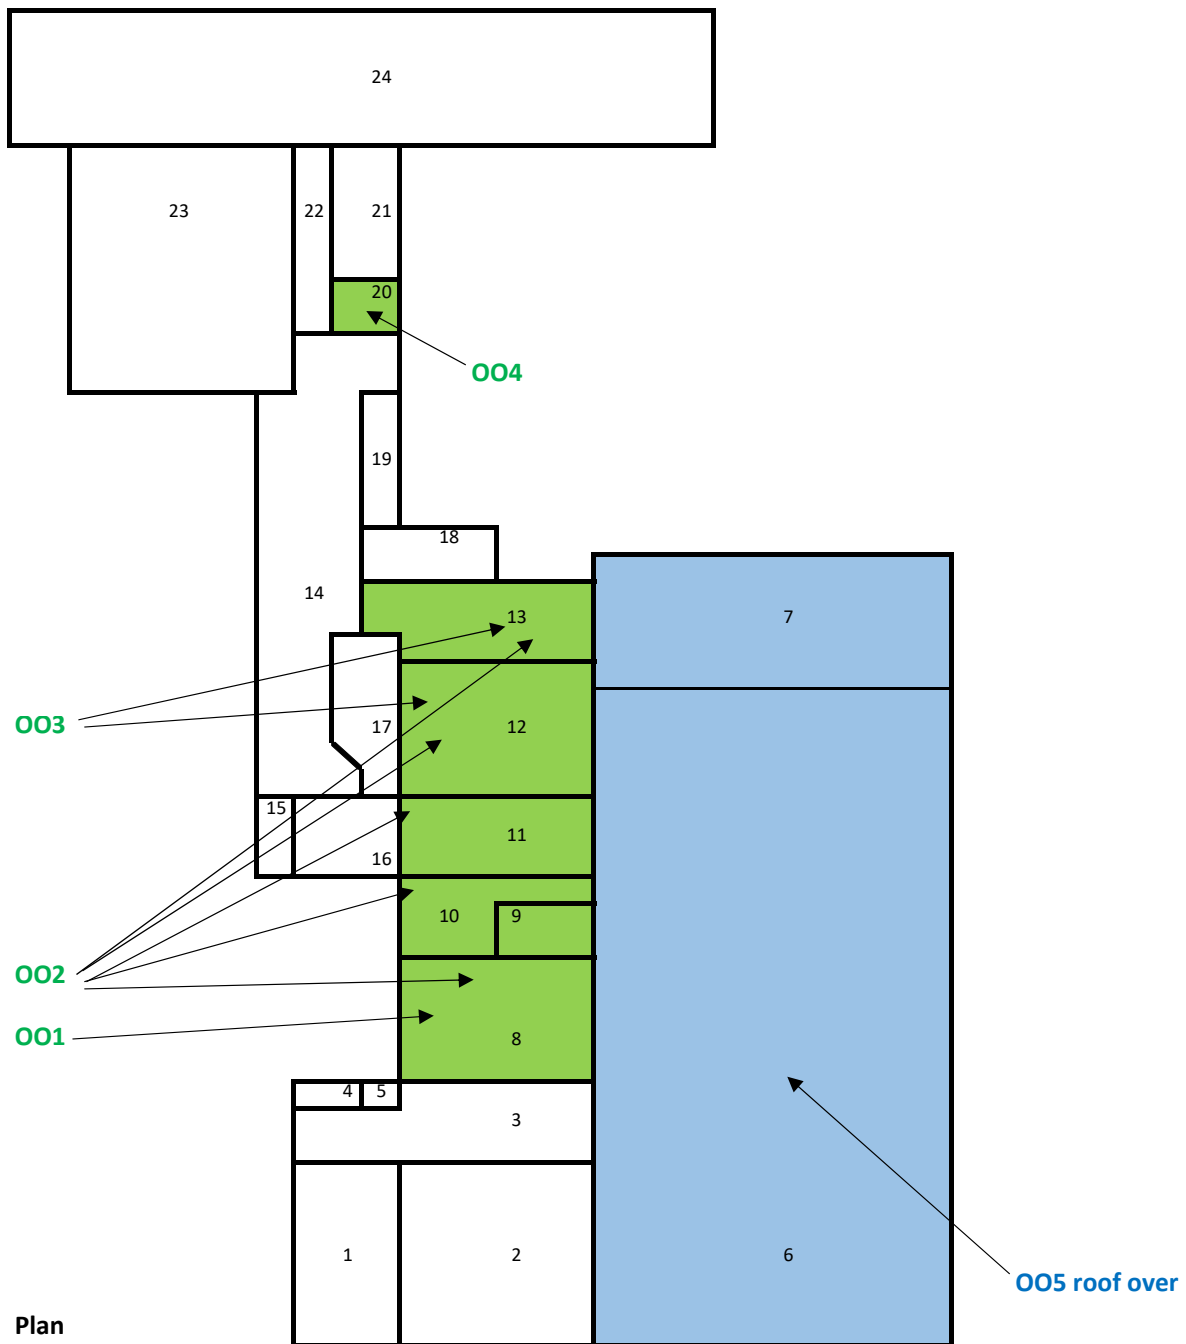
## Amenity Centre, Yaxley Parish Council

Areas highlighted in red indicate an Asbestos Containing Material Present

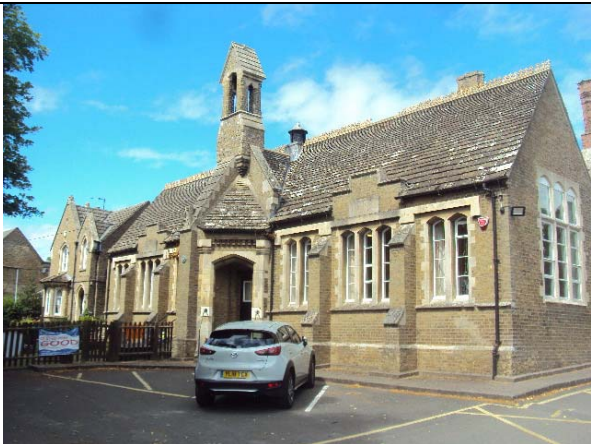
1

<p>External view. Slate roof, stone/brick walls, plastic rainwater goods. No asbestos containing materials seen here.</p>
2

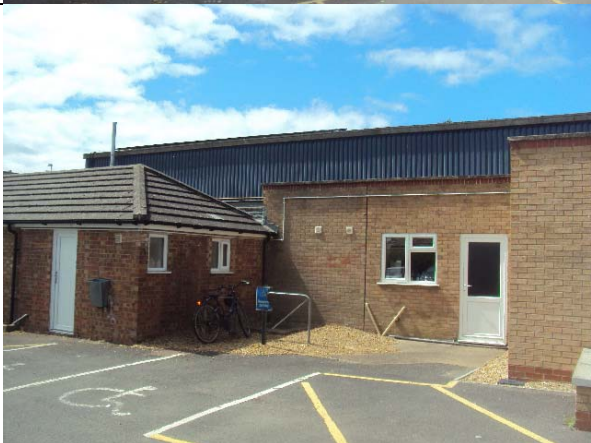
<p>Buildings to the sports field end of the centre are more modern. Sample 005 refers to roof sheets.</p>
3

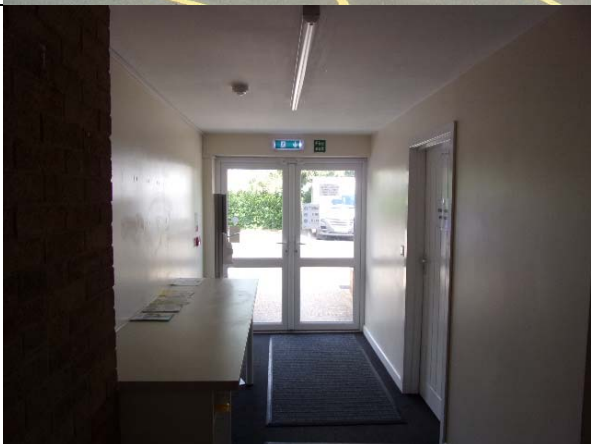
<p>Modern office addition. All finishes checked. No asbestos containing materials seen here.</p>
4

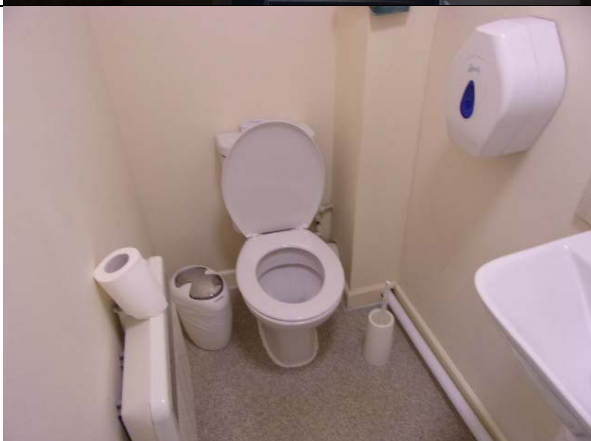
<p>China sanitary units with plastic drainpipes. No asbestos containing materials seen here.</p>

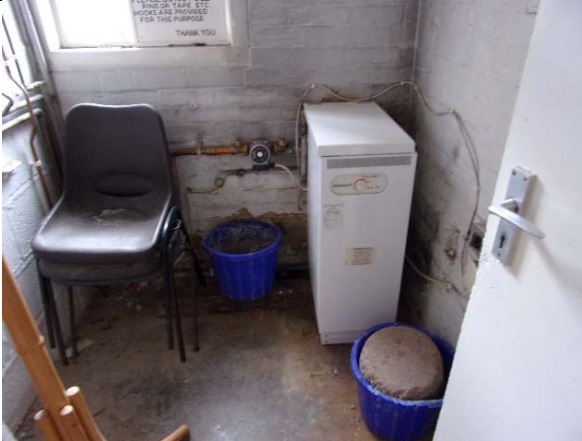
9

Boiler does not contain asbestos products according to HSE list.
10

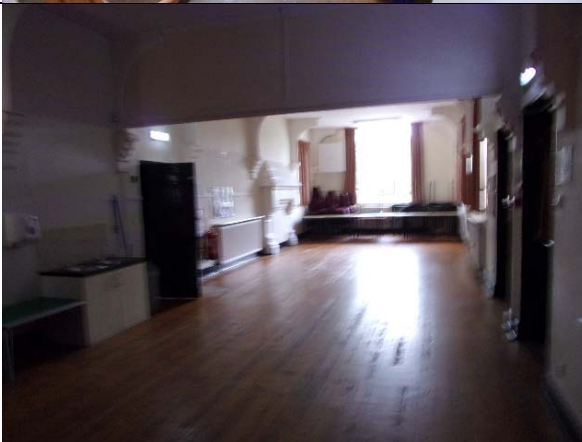
Brick/stone decorated walls, timber floor, plaster to ceiling. No asbestos containing materials seen here.
11

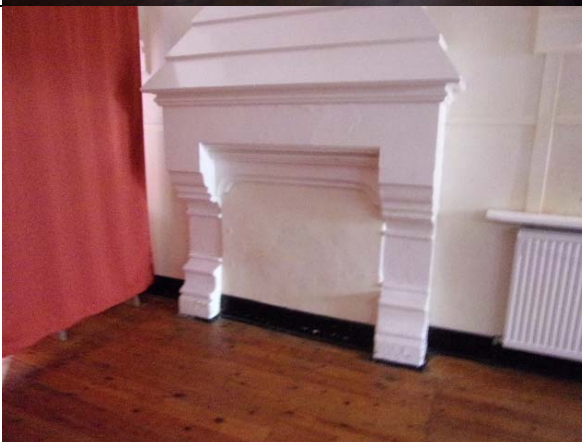
Old fireplaces are bricked up. No asbestos containing materials seen here.
12

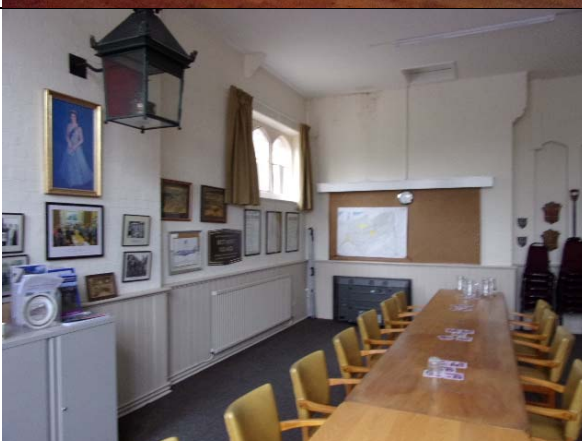
All rooms accessed including the Council Chamber. No asbestos containing materials seen here.
